HEALING AN OPEN SORE REHABILITATION OF FORMER SHALE QUARRIES IN NOVA SCOTIA

Scott MacKnight, Ph.D., CEA, CESA, OCL Services Ltd. 47 North Street, Dartmouth, Nova Scotia B2Y 1B7

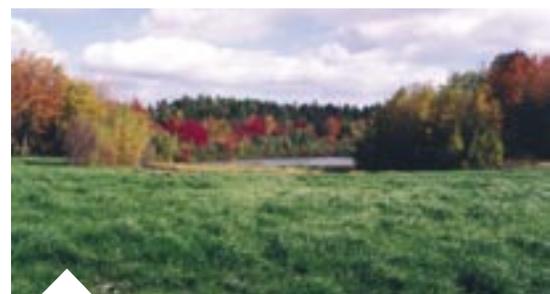
2001 VIEW OF NORTHWEST SHALE QUARRY AFTER REHABILITATION.

In 1998, the first large-scale trial of Remediation Matrix was attempted at the Northwest quarry. Mixture materials were carefully ground at the HCDR facility in Halifax, transported to the site and spread over all of the pit area to a depth of about 1 m. After natural consolidation of the material over a winter, the surface was covered with about 0.1 m of compost and seeded. Within six months, the site started to become a grassy field. Re-seeding in the autumn yielded a lush field of grass the following summer. Excess surface water drainage through the site resulted in sulphide odours during the next three years. This was mostly addressed by diverting surface drainage from other areas around

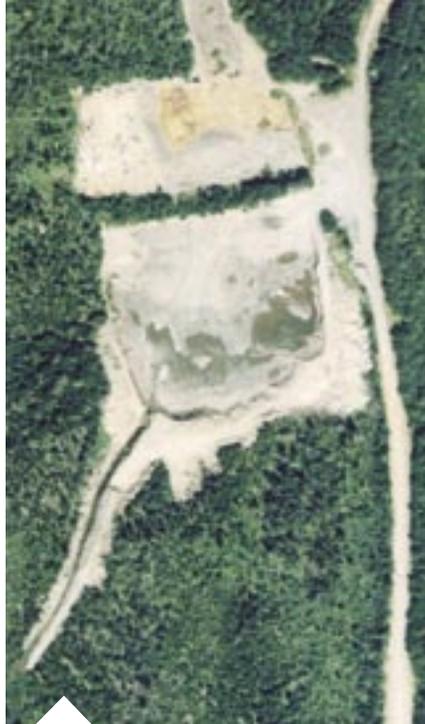
1999 SUMMER AERIAL PHOTOGRAPH OF ANTRIM SHALE QUARRY.

In 1999-2000, a much larger trial of the Remediation Matrix was conducted at a quarry in Antrim near the Halifax International Airport. This 25-hectare site, consisting of two large pits, had been established in the 1950s and used until the late 1970s. The site drainage had a pH of 3. The resultant impact to Nuttall Brook created a very acidic aquatic habitat.

A total of over 10,000 metric tonnes of Remediation Matrix was placed in combination with a site drainage plan and drainage pipes. The large quantities of Remediation Matrix and of compost were used to restore the natural topography and contours of the area, as well as remediate the acidic drainage.

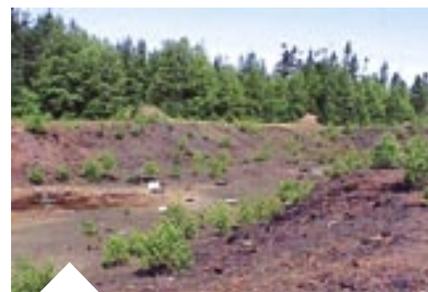
JULY 1999 VIEW OF ANTRIM PIT 2.

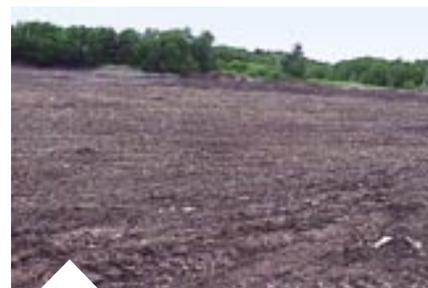
AUGUST 2003 VIEW OF ANTRIM PIT 2 AFTER APPLICATION OF MATRIX AND BEFORE SEEDING.

Two key changes were made in the process: the Remediation Matrix materials were ground much finer than for the Northwest quarry to improve the chemical reactivity, and the amounts of drywall/plaster board were reduced to reduce the sulphide generation problem. By 2004, the former open sore had become two grassy fields.

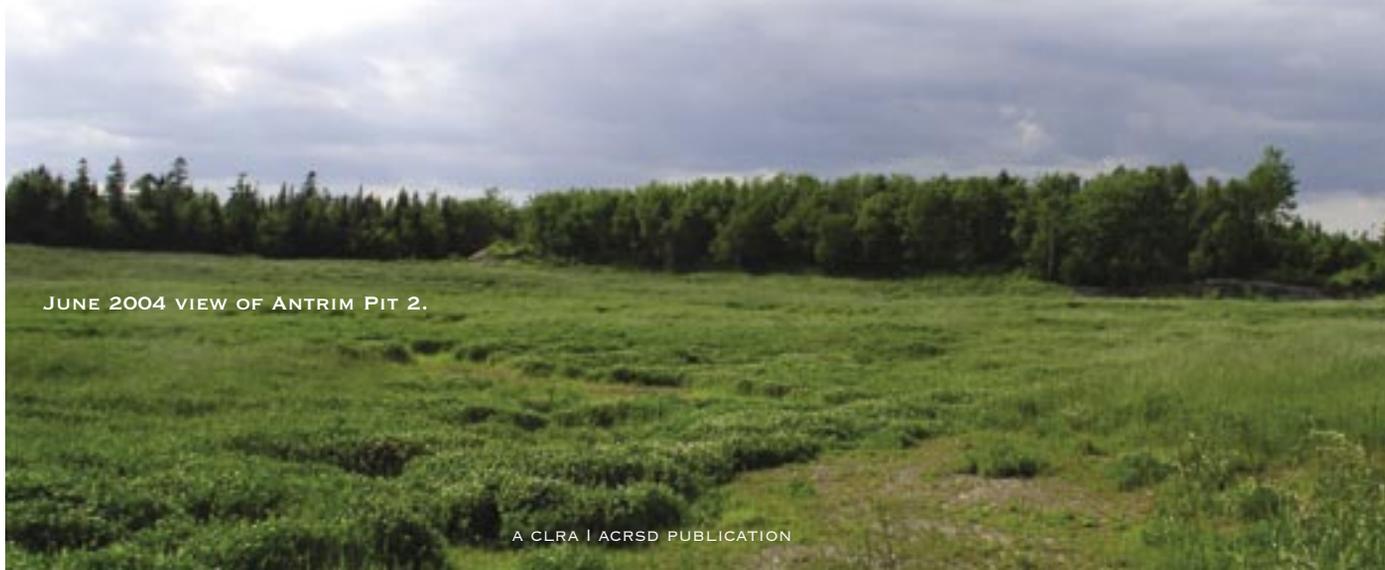
JUNE 2004 VIEW OF ANTRIM PIT 2.
